# LELAND VALLEY ROAD WEST FLOOD REPAIR

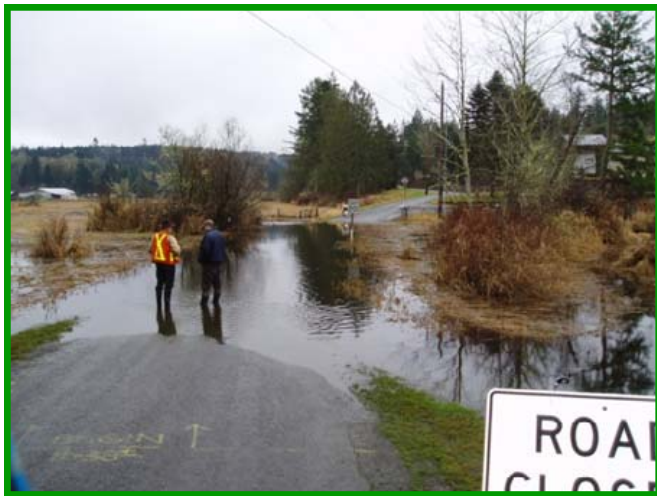
1. Because of severe flooding, Leland Valley Road West was closed to through traffic, creating a traffic detour for local residents that was more than five miles long.

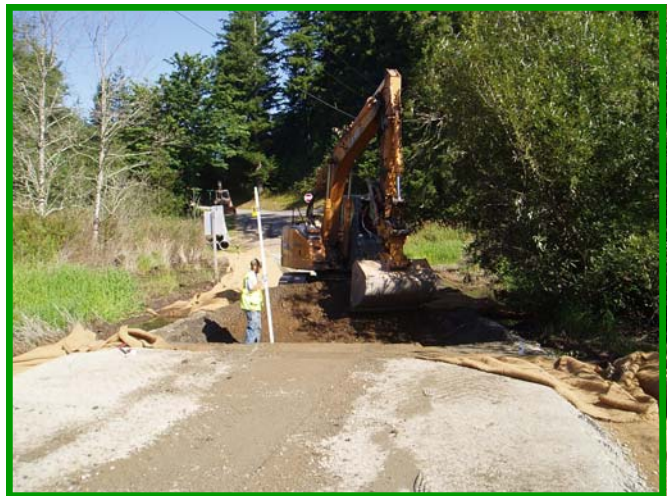
2. The old road bed was excavated to install five new culverts.

Five new cross culverts, in addition to one already in place, ensure water will pass under the roadway rather than over it.

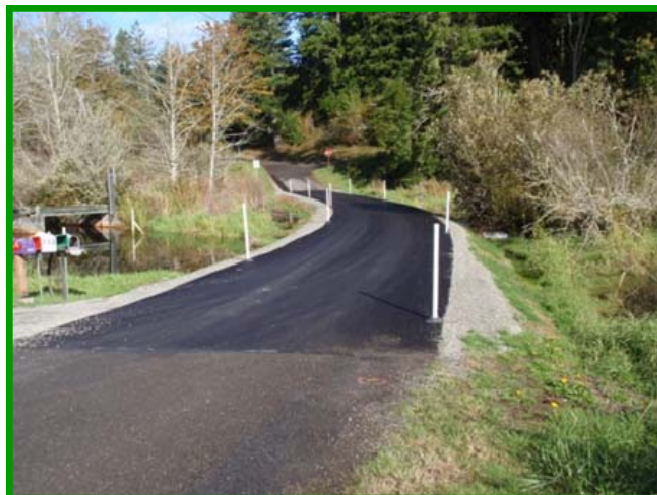
4. Asphalt surfacing completed the successful repair.

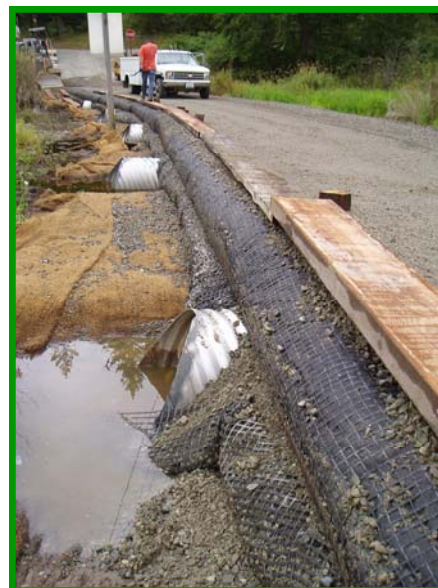
3. Construction included raising the road bed two feet with geogrid wrapped gravel layers to ensure road stability and placing and compacting crushed gravel surfacing.
